Post cleanup composition and geochemical analysis of historic gold processing residues

A Senior Thesis

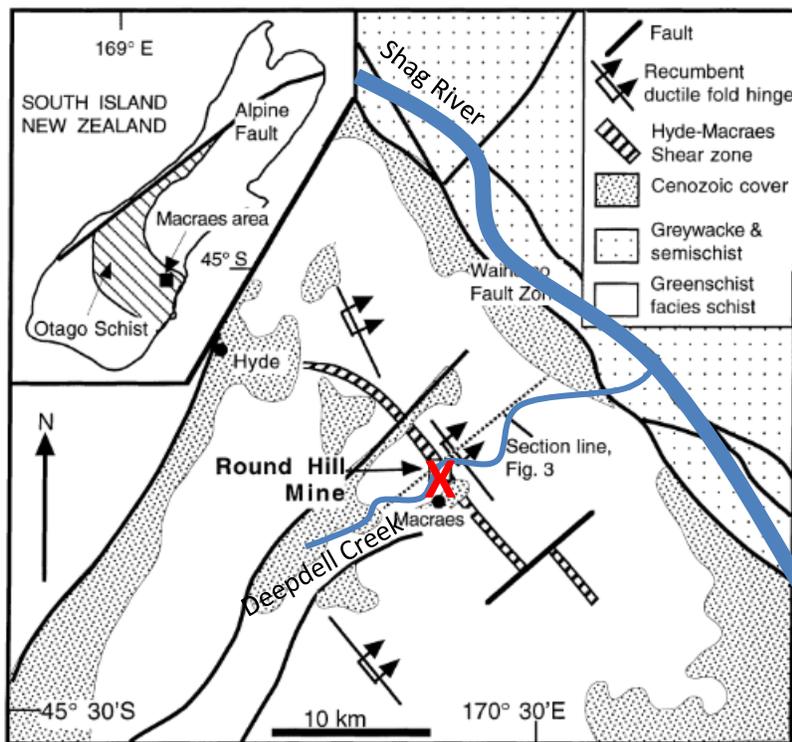
The source of the gold mineralization at the site is the Hyde-Macraes shear zone. The shear zone is around 30 km long, and roughly 10 meters wide at either end. In the center it is up to 120 meters wide. The extent of the shear zone and location of the site within can be seen in Figure 1.4. The shear zone results from thrust faulting between 130 and 140 million years ago. At that time, the zone was around 10-15 km deep (Teagle 1987). The reverse faulting is shown in Figure 1.5.

Figure 1.4 The Hyde-Macraes shear zone and surrounding geology (Craw, Windle et al. 1999). The red X shows the Golden Point study site.

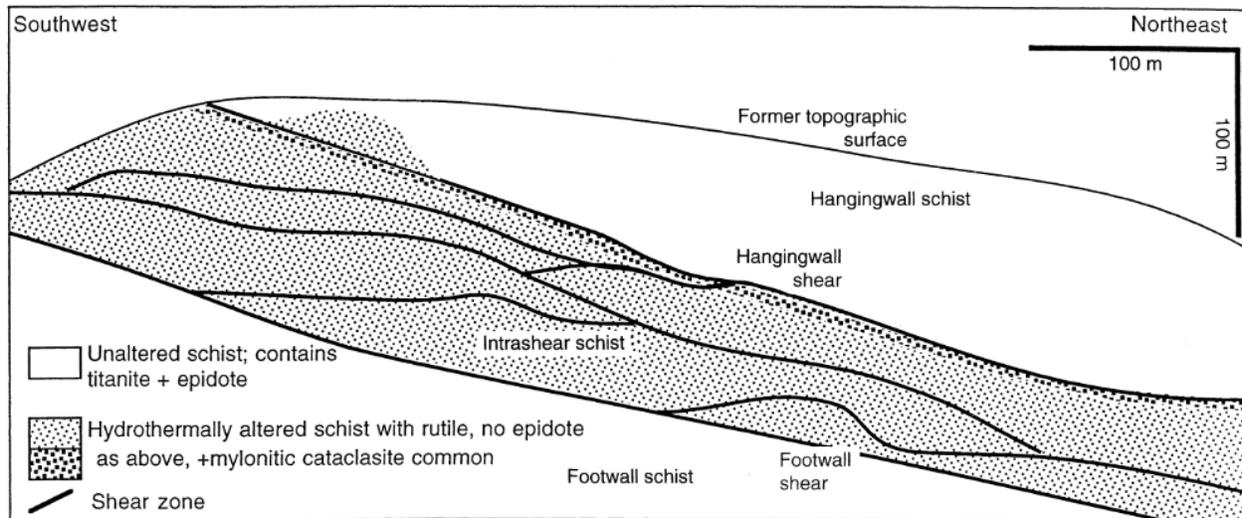
Figure 1.5 a section line of the Hyde-Macraes shear zone. This section is shown in Figure 1.3 as “Section line Fig. 3”(Craw, Windle et al. 1999).

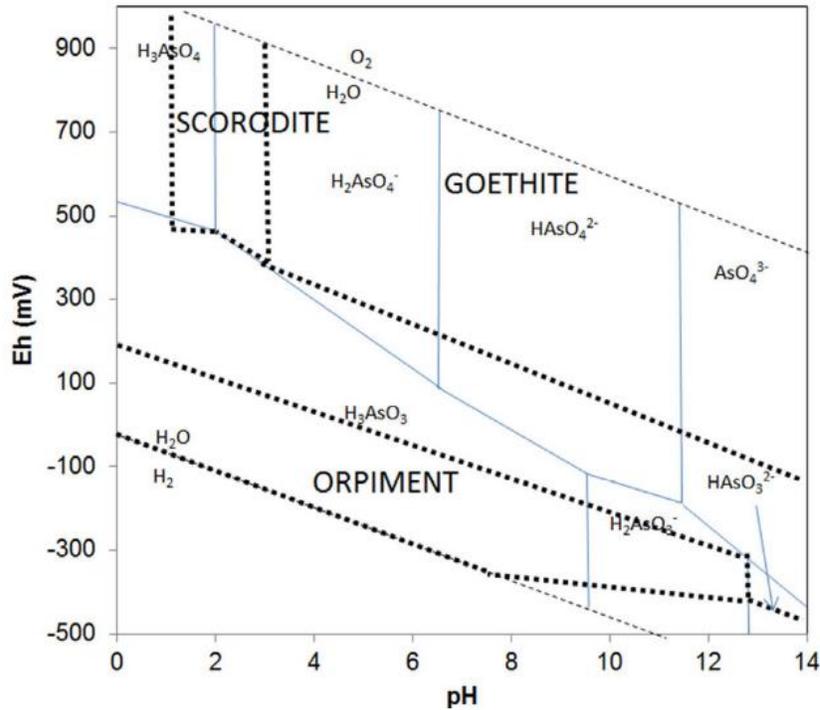
higher pH, goethite is more common than scorodite. Scorodite is insoluble at low pH, but as pH rises, it becomes soluble in water (Mains and Craw 2005). These changing mineral stabilities based on pH are shown in figure 2.1.

Figure 2.1 The stability of As containing minerals at different Eh (higher Eh means closer to the Earth’s surface) and pH (Bowell and Craw 2014).

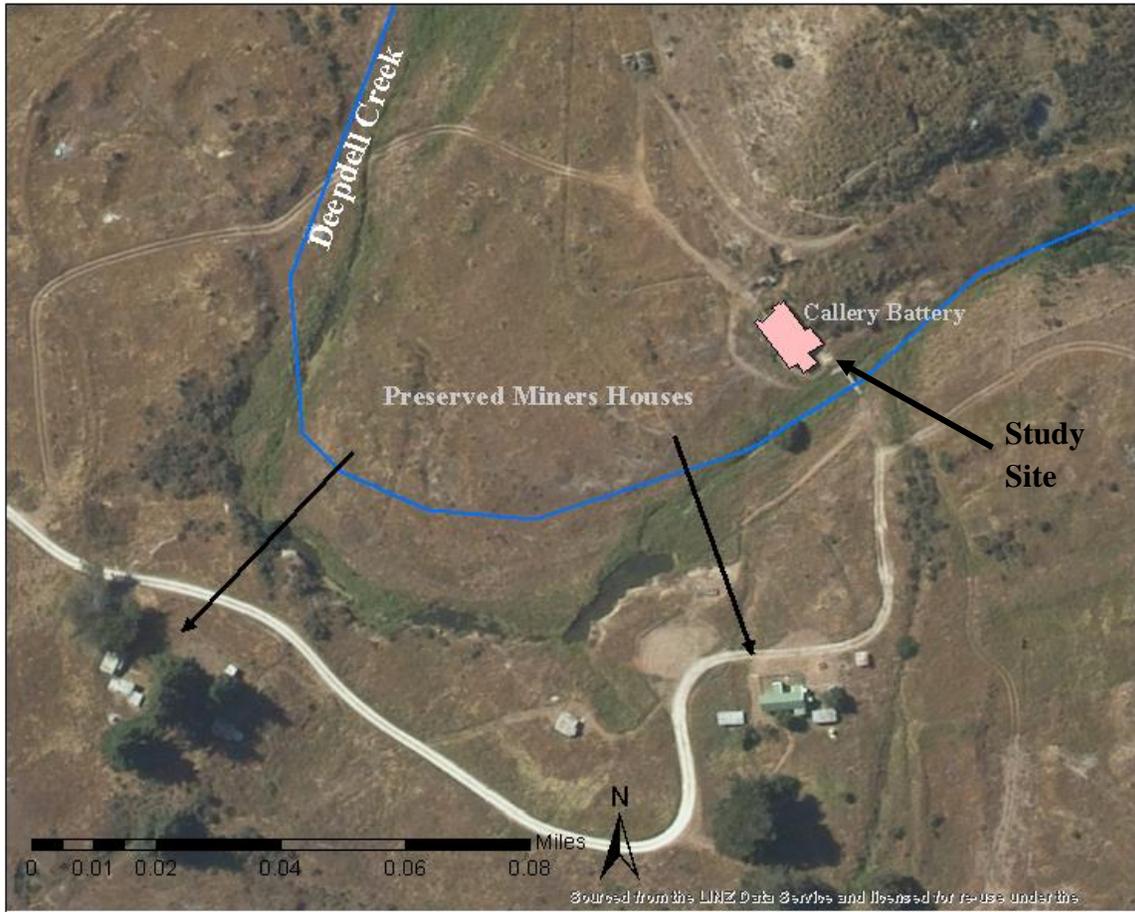
The first battery at the Golden point site was constructed in 1889. A series of several batteries were built in the area in the early 1900s. Processing of the low grade ores was difficult by the techniques of the time (Teagle 1987). By 1960, all but one battery had been turned into scrap. This study focuses on the one remaining battery, known as the Callery battery. After its closing, the battery and surrounding area were turned into a historic reserve by the New Zealand Department of Conservation (DOC). The Callery battery, where this study focuses, is shown in Figure 2.2.

Figure 2.2 The Callery Battery, study site, and surrounding area. Deepdell creek flows from the left to right.

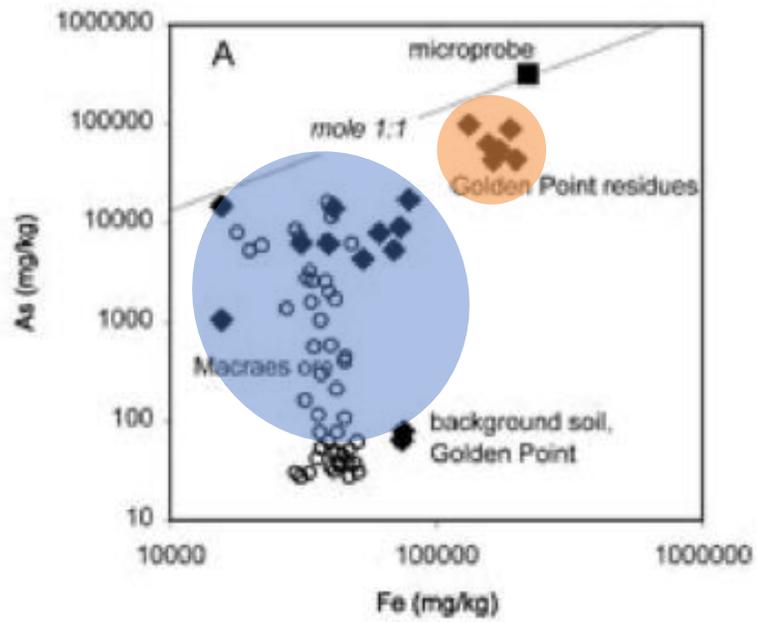
Figure 2.3 The biplot of As and Fe from Mains and Craw 2005

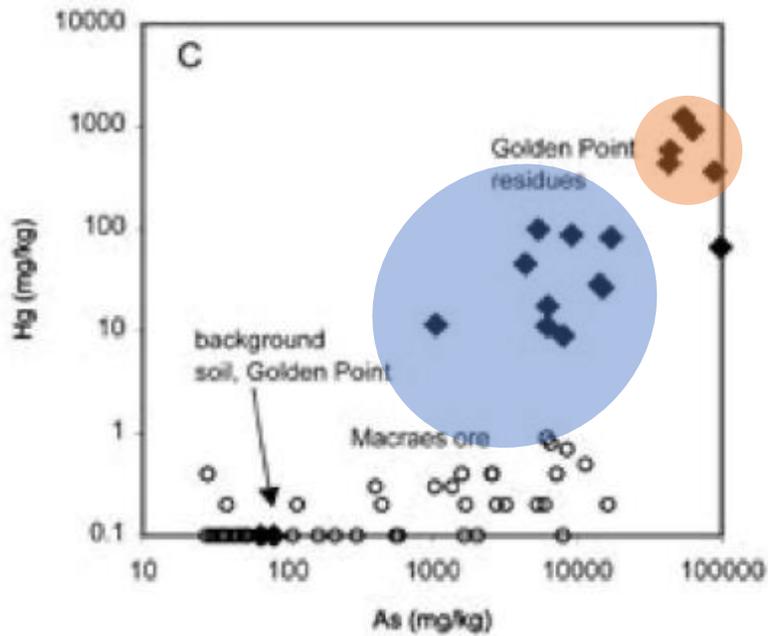
Figure 2.4 The Hg to As biplot from Mains and Craw 2005

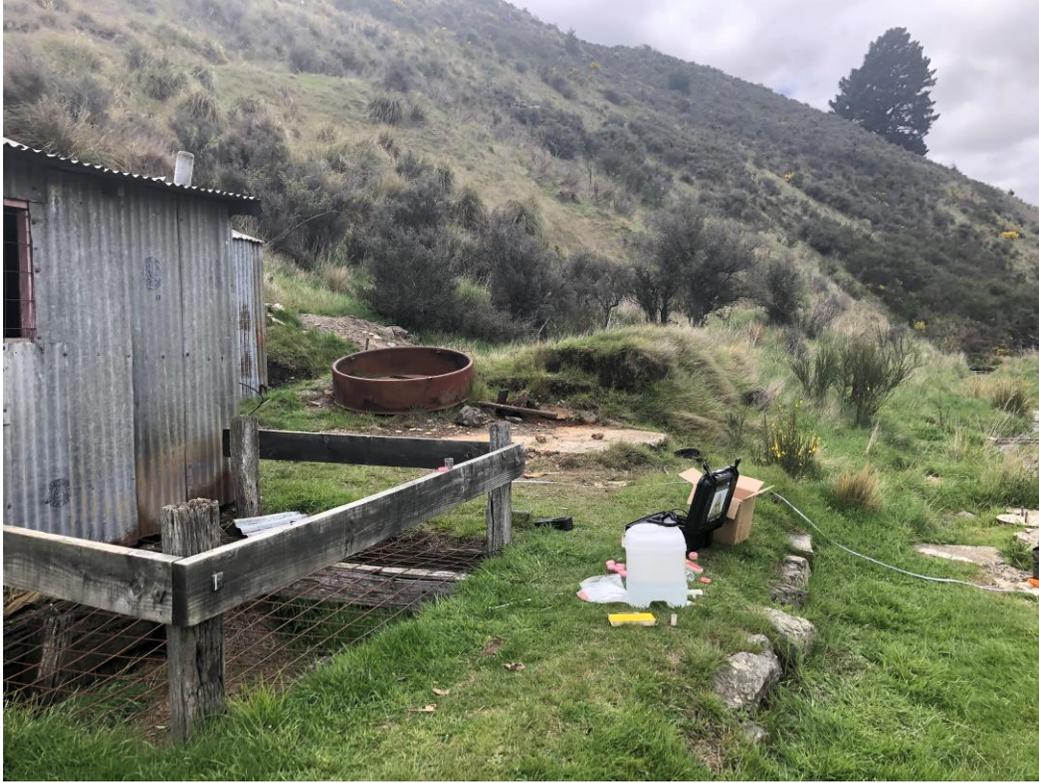
Element concentration measurements at the site were taken along a series of 11 transects spaced 0.5 m apart. Along the transects, a measurement was taken every 0.5 m. The resultant grid of measurements was 5.5m by 10.5 m. Spatial accuracy was accomplished by laying measuring tapes across the ground, seen in Figure 4.1. Each measurement took around two minutes to complete with the handheld X-ray fluorescence gun, so it would not have made sense to take more than the 230 measurements taken. However, with a 0.5 m interval between measurements, it could be reasonably assured that there would not be too much meaningful data missed by the study. The sample collection was spaced enough to be practicable, but not so widely spaced that key data was missed.

Figure 4.1 The Callery battery site during data collection in November 2020. Note measuring tape for one transect on the right side of the photo.

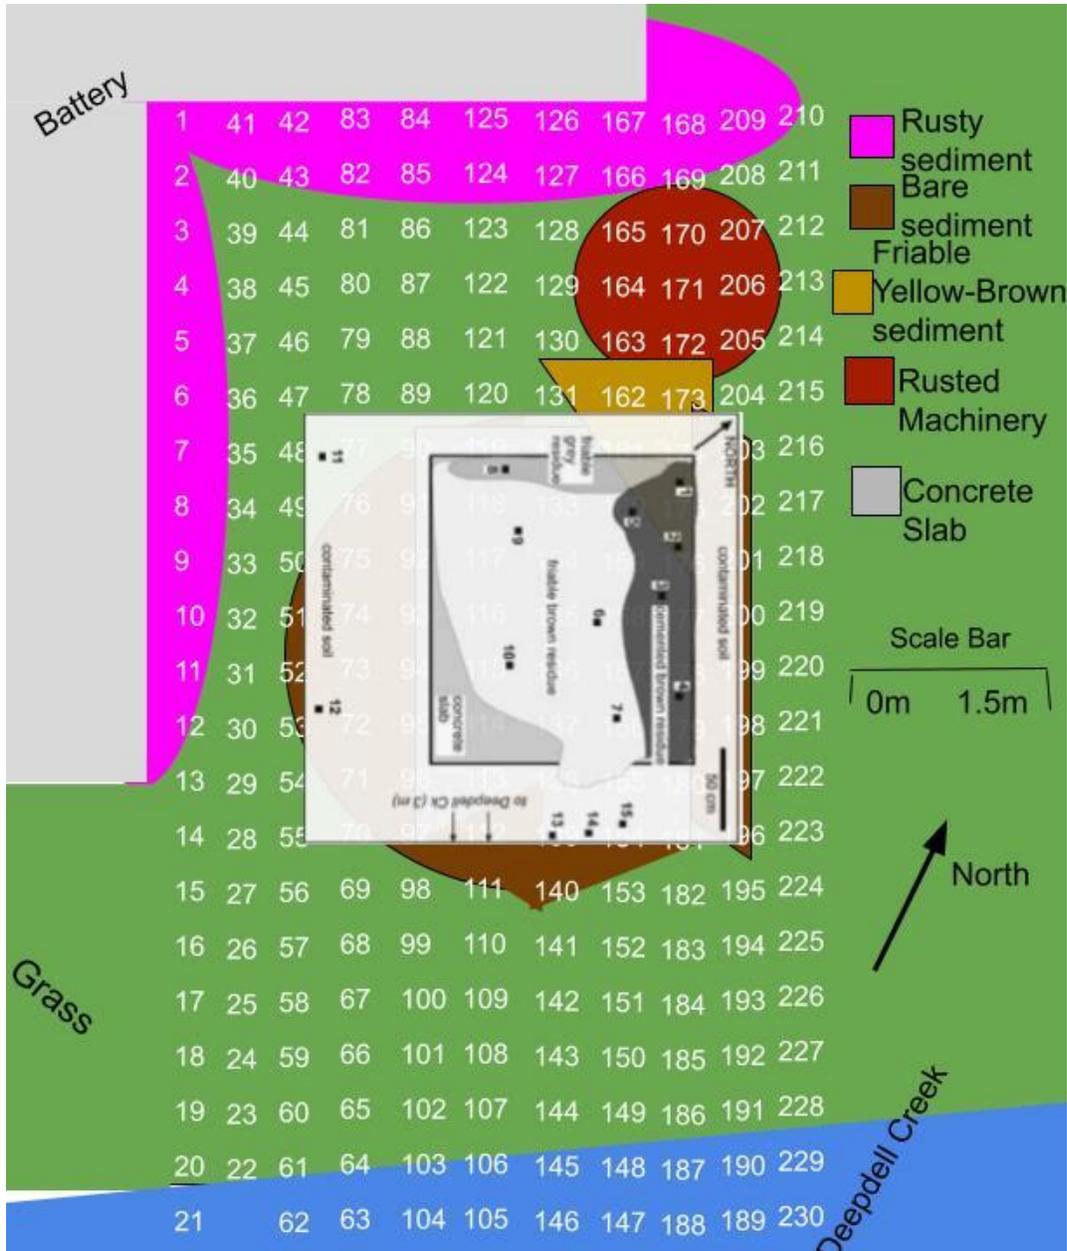
Once samples were collected, analysis began. With a principle focus on As, a heatmap of As concentrations was created. This was difficult since the line orientation was ~ 48 degrees offset from North. The solution was to create a continuous line in GIS which snaked its way through all the measurement locations. The line was then populated with points every 0.5m. The object ID of each point was then matched to that of the corresponding measurement. This was repeated with Fe and Hg. For further analysis and comparison, biplots similar to those created by Mains and Craw were created. Furthermore, pH was graphed against transect maximum As concentration. The surface of the area in the 2020 study was divided into 6 different surface types, all of which are labelled in Figure 4.2.

To better understand the effects of the cleanup, a direct comparison was made to Mains and Craw 2005. The 2005 paper had a map of residue types and the measurements taken. By looking at the North arrow, the scale bar, and the distance to Deepdell creek, the figure was approximated to be in the center of this studied area. The Mains and Craw map superimposed onto the map of measurements in this study is

shown in Figure 4.2. A closer look at the Mains and Craw map is shown in Figure 4.3. From this map and the residues described, as well as the accompanying tables in Mains and Craw, a direct comparison between the same surface areas in these two studies could be made. Measurements taken in the same place were compared with one another to give the best view possible of the changes resulting from the cleanup.

Figure 4.2 the map from Mains and Craw 2005 superimposed on a map of all 2020 measurements and surface types.

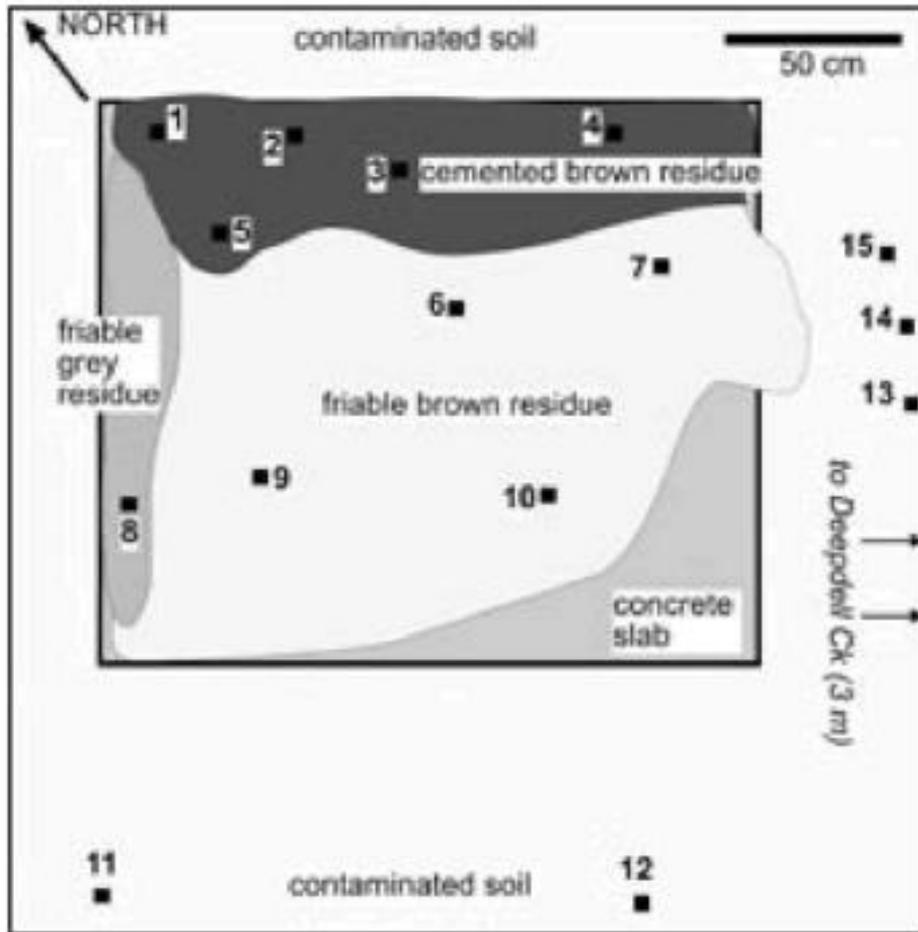
Figure 4.3 The map from Mains and Craw 2005, showing the surface types in the study.

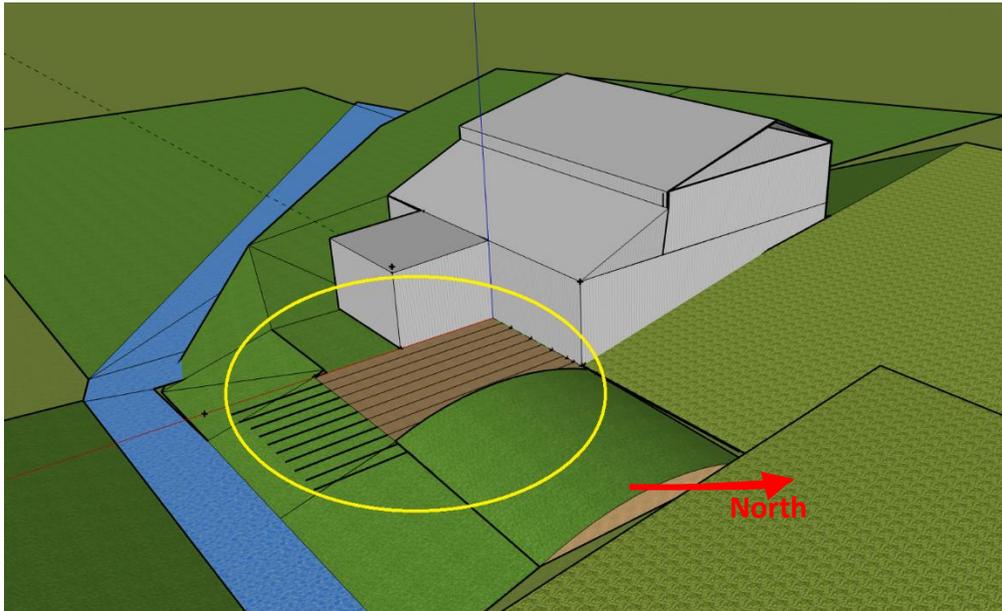
Figure 5.1 the site is shown in a 3D computer rendering, with the transects shown as the black lines within the yellow circle. This gives a better idea of where the site was in relation to the battery and Deepdell creek. Created using Sketchup computer program.

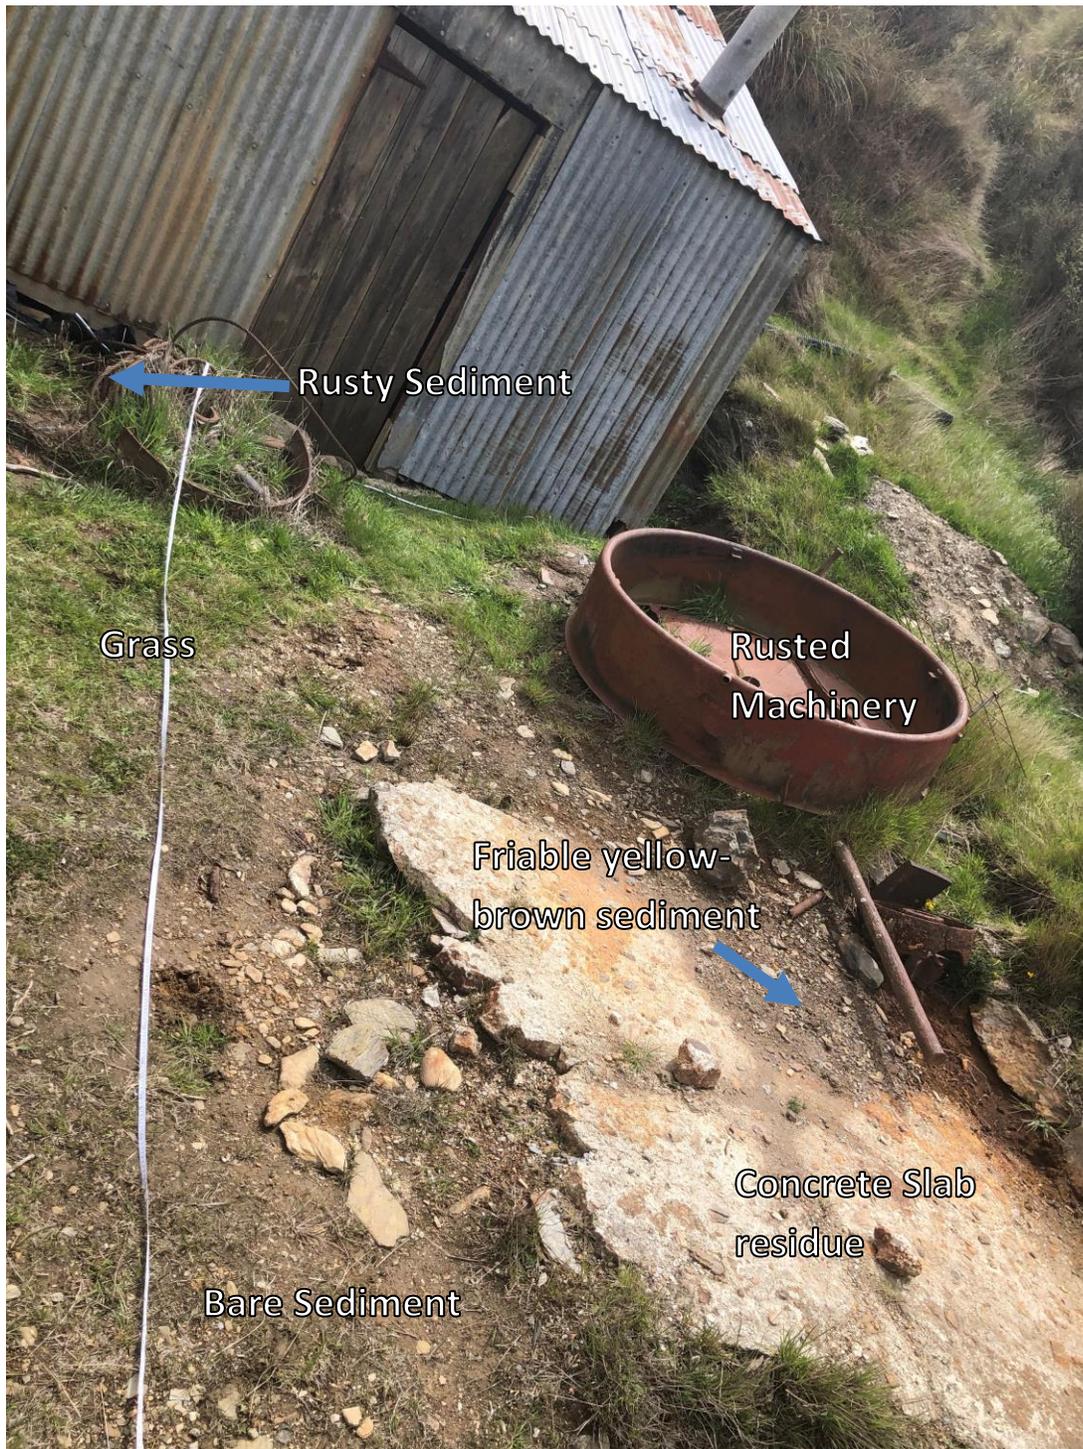
The study site can be characterized by six surface types: grass, rusty sediment, bare sediment, concrete slab, friable yellow-brown sediment, and sediment near rusted machinery. The grass had varying distribution, some of it being mowed on a regular basis by DOC as a part of maintenance of the historic reserve, but some of the grass closer to rusted machinery was longer as it could not easily be cut. The rusty sediment was generally next to the battery (refer to Figure 5.2, 5.3) and had a reddish brown tinge. The bare sediment is differentiated from the rusty by being closer to the center of the site and the concrete slab, rather than near the edge of the battery. The most interesting residue for this study is the friable yellow-brown residue on the right hand side of the concrete slab (see Figure 5.2, 5.3). This was a relatively small area, but due to its complete lack of any vegetation, high readings were expected.

Figure 5.2 the surface types are labelled on an image from November 2020 during data collection. Rusty sediment is somewhat obscured behind grass and machinery.

The rusting, or oxidation of iron machinery in the vicinity is likely to blame for the increased levels of Fe. Every piece of machinery had some sort of rust on it (see Figure 5.2), and much of the sediment not covered by grass had a distinct rusty tinge. On the East side of the Southern Alps, there is little precipitation in North Otago at the Golden Point site so rusting would not occur as quickly as in a wetter environment (Craw and Pacheco 2002). The decomposition of the scorodite, by the process described in the previous paragraph, could also play a role in increasing the Fe levels in the soil.

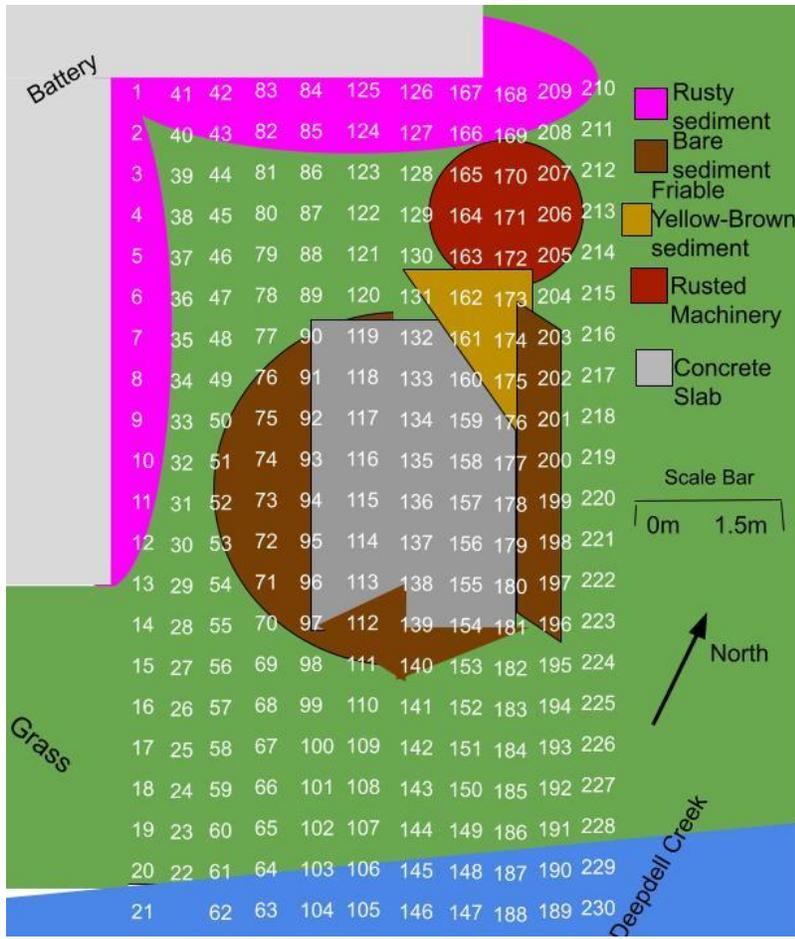
Figure 5.3 A map of the studied area. Each white number represents a site where data was collected. Some data points look as if they are in Deepdell creek, but those which would have been in the creek were not collected. However, in order to easily import the points into GIS, it was convenient to assign object IDs to points that weren't collected.

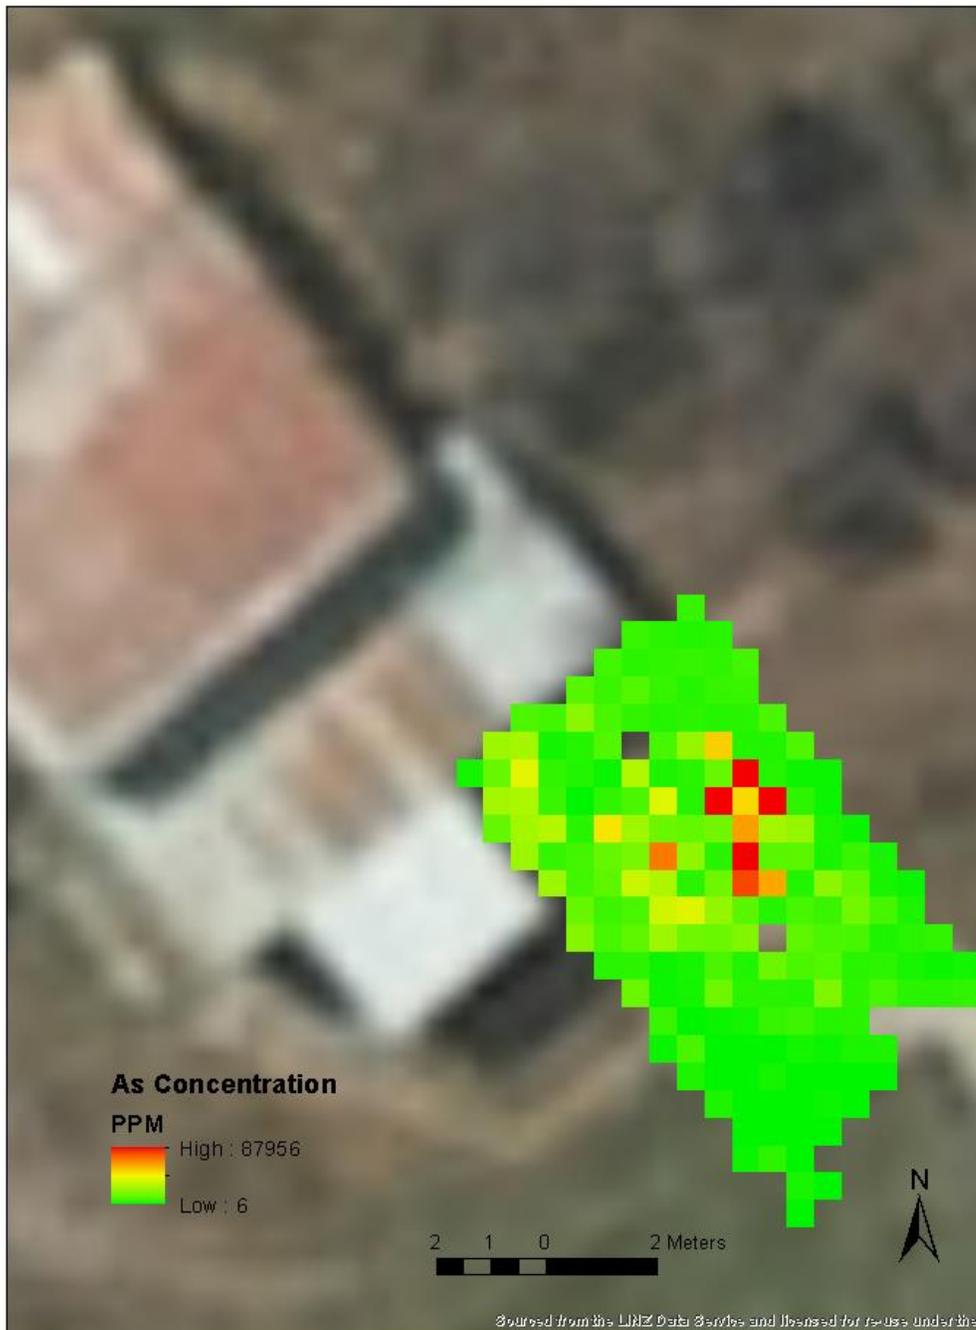
As Concentration

As concentration was greatest at sites 173 and 159, in the region of the yellow-brown sediment and the concrete slab residue, respectively. The maximum reading was 87000 ppm. Elevated levels were also observed near rusted machinery at concentrations up to 66379 ppm. The rusty edge near the corner of the battery edge also yielded some elevated concentrations at sites 40 and 43, with values ranging up to 13943 ppm. As levels in the grass maxed out at 24241 ppm.

Figure 5.4 A heatmap of As ppm is shown, a section of high concentration can be seen in the cross shape on the right hand side.

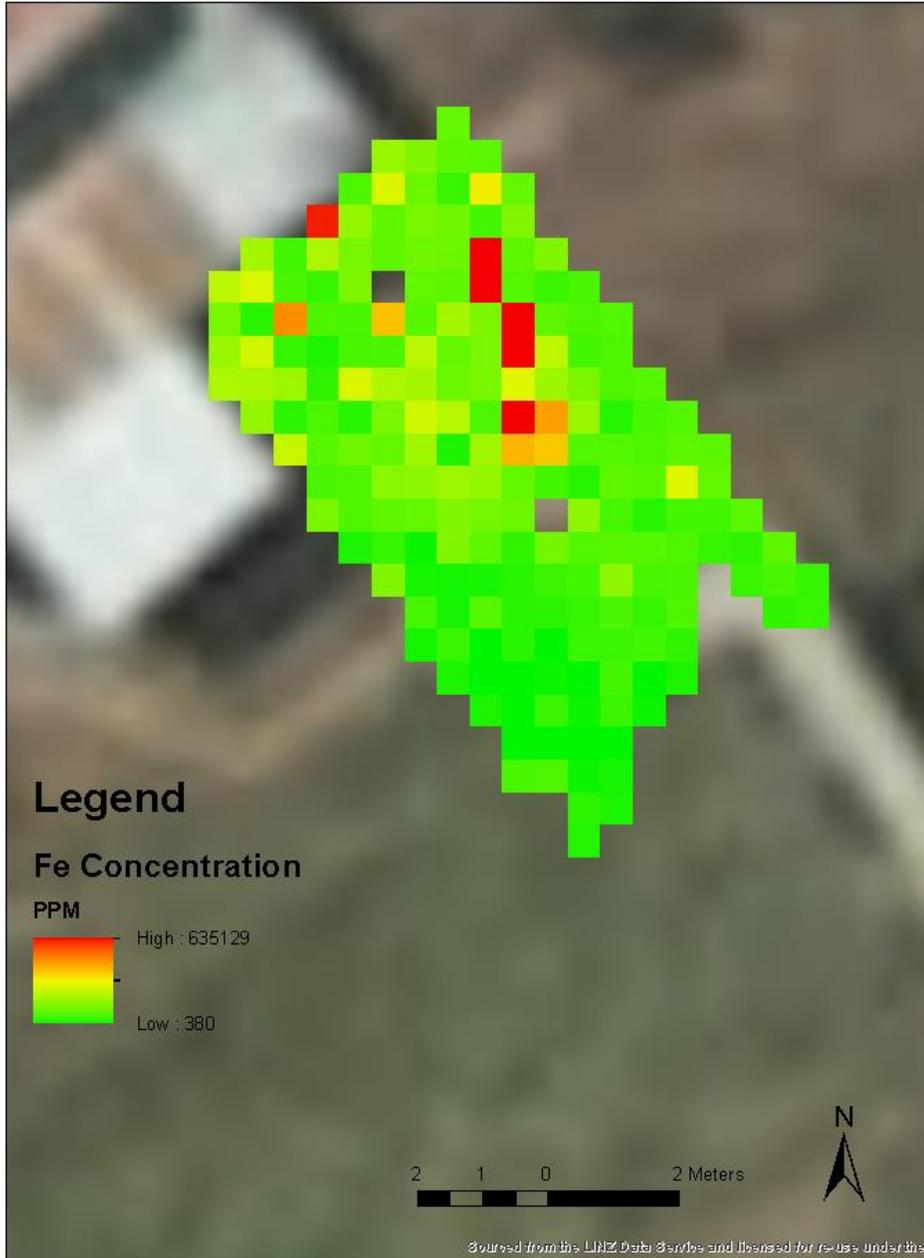
Fe Heatmap

Figure 5.5 The heatmap of Fe is shown, with a section of elevated values shown on the top right.

Fe was the most abundant of the elements studied, with a top concentration of over 635000 ppm, once again at site 173. The upper yellowish sediment has significantly elevated values, with a maximum of 635129 ppm. The residue atop the concrete slab at site 159 with a concentration of 333673. In the rusty sediment area, there is a significantly elevated value of Fe, with a value of 424729 ppm.

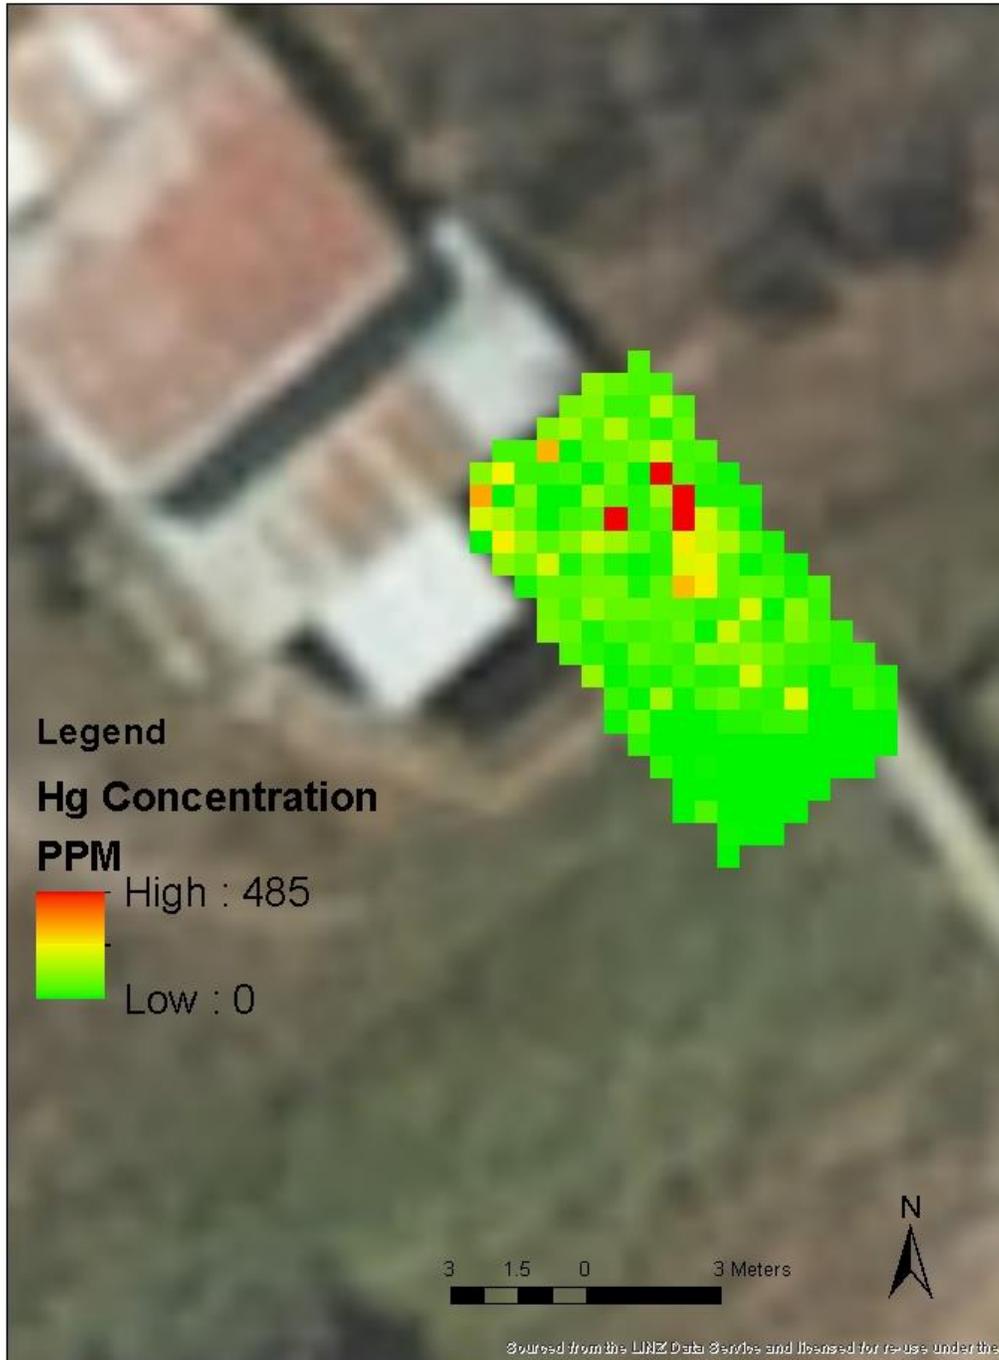
Hg Heatmap

Figure 5.6 Hg concentration is shown, with a clear example of elevated values shown on the top right

Hg concentrations are very low throughout the study area, with a maximum concentration of only 485 ppm. The high was once again at sites 173 and 172. These surfaces were the friable yellow-brown sediment and the rusting machinery. There were also elevated concentrations at site 119 on the concrete slab, as well as a high for the rusty sediment of 90 ppm at site 84.

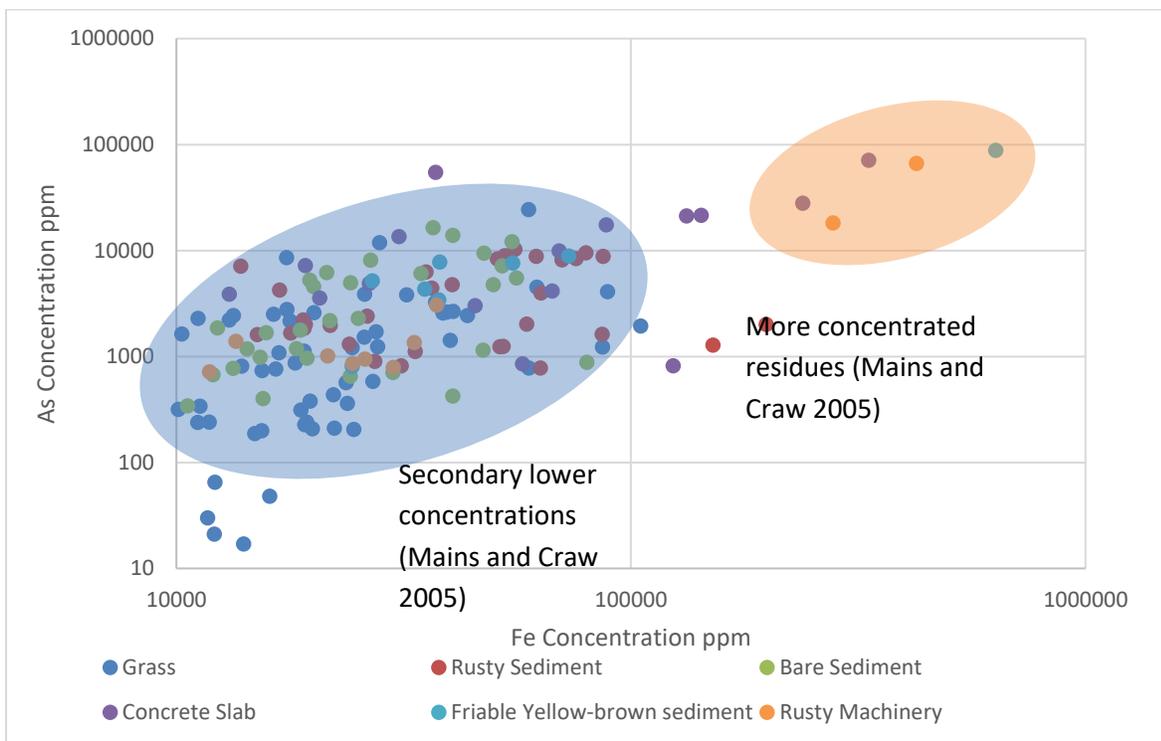
Figure 5.7 A biplot of As and Fe. The secondary lower concentrations and an area of more concentrated residues from Mains and Craw 2005 are labelled on the biplot.

Fe concentrations are mostly below 100000 ppm, just as most As values are below 10000 ppm. However, there are quite a few outliers with As concentrations above 10000 ppm and Fe concentrations above

100000 ppm. Friable yellow-brown sediment has the highest readings for both, followed by rusty machinery and concrete slab.

This story continues with the As to Fe ratio. There are only a few measurements that have very high As concentrations, but the Fe concentration seems to have increased since 2005. The Fe concentration in 2005 was a maximum of 199000 ppm, while in 2021 the highest reading was 635129 ppm. The change in averages is a similar story, with an increase from 81240 ppm average in friable yellow-brown sediment to 115675 ppm in 2020 in the same surface type (see table 1). As has little significant change in maximum values (the max recorded by Mains and Craw 2005 was 98300 ppm in friable yellow brown sediment, while the max recorded in 2021 was 87956 ppm in the same surface type), but the average values in 2021 are starkly lower, with an average of only 15741.4 ppm in friable yellow brown sediment. These data suggest that the Fe concentration has somehow increased, but this is of little concern to the cleanup success as Fe is not a toxic element. These data also suggest that there are still areas of concentrated As, but the overall average has dropped significantly. This is once again consistent with the idea that after 2005 most cemented residue was removed from the site, but the secondary, friable residue remained.

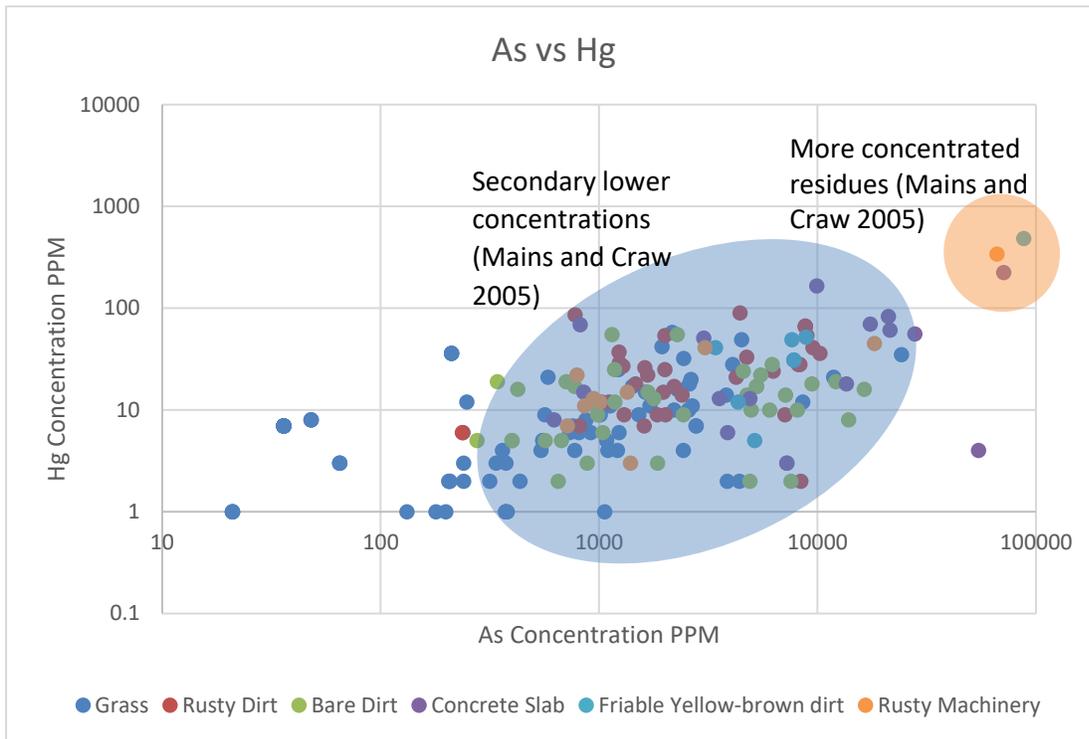
Figure 5.8 the concentration ratios of As and Hg, with the site of each point of elevated reading labelled. The zone each came from is labelled as well. The region where each point falls on the Mains and Craw 2005 graphs is shown in the orange and blue regions.

The ratio between Hg and As is very low, as Hg generally had very low readings. It does, however, show a reasonably strong correlation, and shows elevated values similar to the elevated values seen in the Fe vs As graph. Once again the yellowish sediment and concrete slab residue has the highest readings, while bare sediment to the side of the concrete slab, as well as rusty sediment from near the battery have the next-highest readings.

The As to Hg ratio exhibits some change between 2005 and 2021. There are no Hg measurements in 2021 which exceed 1000 ppm, but there are a few around the 1000 ppm mark in the 2005 data. This change is consistent with the idea that the 2005 cleanup removed all the cemented residue from the site. Cemented residue had an average Hg concentration of 710.8 ppm. This is hundreds of ppm higher than the highest value reported in the 2021 data. This leads to the conclusion that the cleanup was successful in decreasing the Hg concentration with the cleanup. The data observed in 2021 is consistent with the secondary “cloud” of values reported by Mains and Craw, but higher concentrations similar to the cemented residue are relatively nonexistent. It can thus be concluded that the cleanup accomplished removal of the cemented residues while secondary residue (the blue circle) remains.

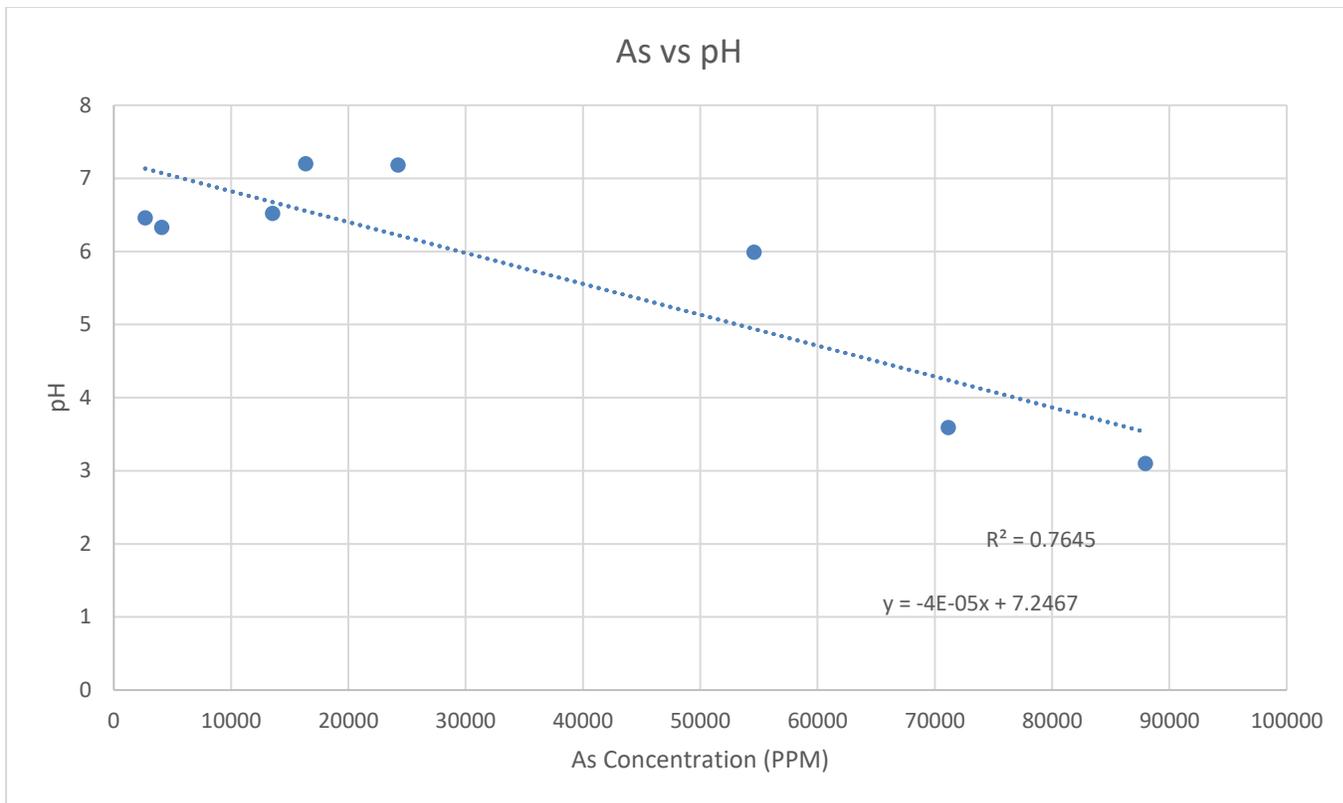
Figure 5.9 As vs pH is shown. Only one pH measurement was taken per line, so the average of each As line is plotted against the line's pH.

At least some of the imprecise distribution of As can be attributed to chemical weathering. Much of the ore involved is arsenopyrite. When exposed to oxidation, the exterior of arsenopyrite pieces become tarnished with scorodite (Drahota, Rohovec et al. 2009). Every piece of rock in the mining process was crushed, and therefore would have the opportunity for oxidation due to an exponential increase in surface area. Scorodite is insoluble at low pH, but as pH rises, becomes soluble in water (see figure 2.1). The continued dissolution of pyrite in the mine tailings keeps the pH low, and the scorodite stays stable. However, once the pyrite dissolves completely, the pH increases and the scorodite is no longer stable. Once tailings gain a more neutral pH, the scorodite will dissolve in rainwater and As will be released (Mains and Craw 2005). Thus, the tailings must remain acidic to avoid As spreading from the scorodite. The graph of As vs pH in figure 5.9 supports this claim, as lower pH areas tend to have higher levels of As.
