C5: The Sandy River Re-visited

Daly, J., Eastler, T., and Locke, D., 2017, The Sandy River Re-visited in Johnson, B. and Eusden, J.D., ed., Guidebook for Field Trips in Western Maine and Northern New Hampshire: New England Intercollegiate Geological Conference, Bates College, p. 317-326.
<https://doi.org/10.26780/2017.001.0018>

THE SANDY RIVER RE-VISITED

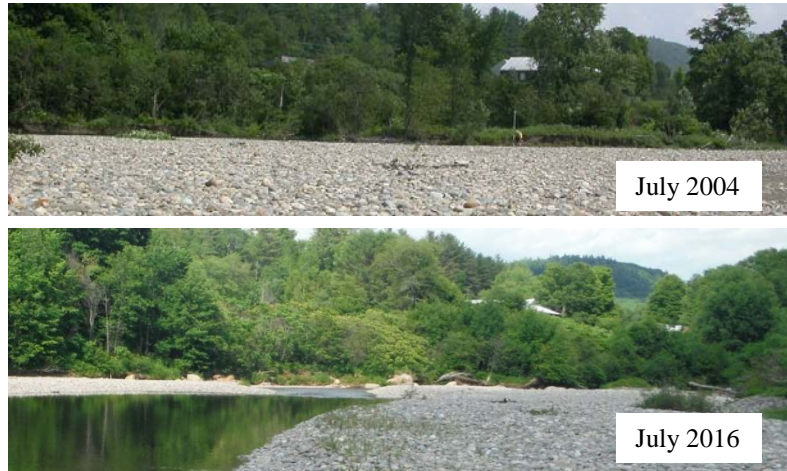
Figure 1. Changes in channel position at Voter Bar, Avon, Maine. The same view downstream (to the east) over an interval of a dozen years shows an example of the major channel migration at this location over time. Buildings at the Voter Vale farm are seen behind the trees in both photos. Channel migration has been a persistent issue at this location for two decades.

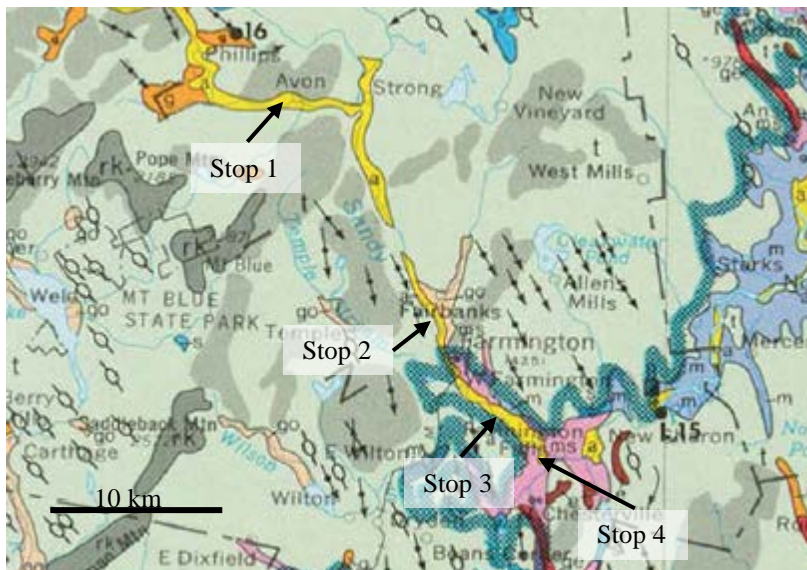
Figure 2. Excerpt of the state surficial geologic map, showing field trip stops (map from Thompson and Borns, 1985). Pale green indicates till, yellow is alluvium, and pink is nearshore marine. The stippled blue boundary indicates a generalized post-glacial marine limit.

slower, deeper channels in the lower section. Figure 2 shows the generalized geologic context of the four field stops. At the upstream field site (stop 1), the channel sits in a relatively narrow valley bounded by till covered hills (Syverson and Greve, 2003). Cobbles, gravel, and sand derived from till and valley-parallel eskers yield abundant sediment. The upper limit of post-glacial marine inundation is likely somewhere between Strong and Phillips, ME. Small nearshore marine deposits (mostly sands and muds) are mapped along the margins of the floodplain from Farmington to Strong (Neil, 2007, and Weddle, 2003) and also contribute some sediment when they intersect an active channel. Downstream of Farmington, the gradient decreases and the floodplain broadens. In this section, the channel incises into the post-glacial marine mud and sand of the Presumpscot Formation overlain by post-glacial stream terraces and floodplain deposits (Weddle, 2003).

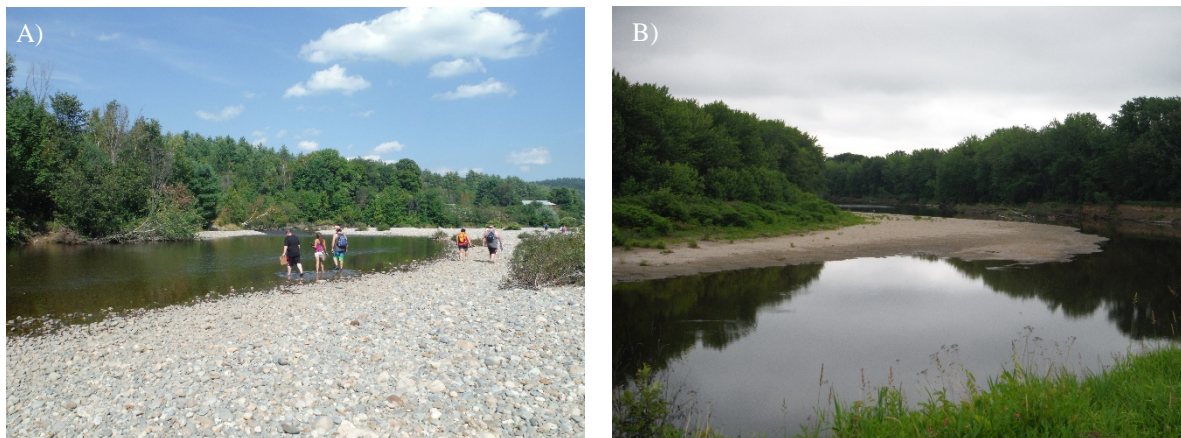
Figure 3. Examples of typical views across point bars on the Sandy River, looking downstream. A) View at Stop 1, typical of the mid-section reaches of the watershed with abundant rounded cobbles on the point bar surface and a relatively shallow channel. B) View at Stop 4, typical of a sandy point bar in the lower reaches of the river adjacent to a wider, deeper channel.

The point bars visited during the trip represent a range of morphologies and grain size that vary predictably moving from upstream to downstream reaches. Farther upstream, the channel is slightly narrower (<50m), shallower (<1m), and water velocities are faster. The surface of many upstream bars is an armor of rounded cobbles and gravel with some interstitial coarse sand. The cobbles are imbricated, and their diverse lithologies (granite, schist, slate, phyllite, chert) reflects their glacial material source. Moving downstream, more and more sand is present on the surface of the bar indicating lower velocities and gentler gradients even as the channel is wider (>50m) and deeper (>1-2m) to accommodate more discharge. The meanders are migrating predictably at each location, slowly increasing curvature and moving downstream simultaneously. When they reach their maximum length, the channel avulses and develops a shorter path. Evidence of old channel positions is found at numerous places along the Sandy River as oxbow ponds or simply abandoned channels beginning to re-vegetate. Our 2006 field guide used high-resolution topographic survey data collected over a period of five years to characterize volumetric change on the bars each year, and concluded that the bars were roughly in equilibrium (Daly and Eastler, 2006).

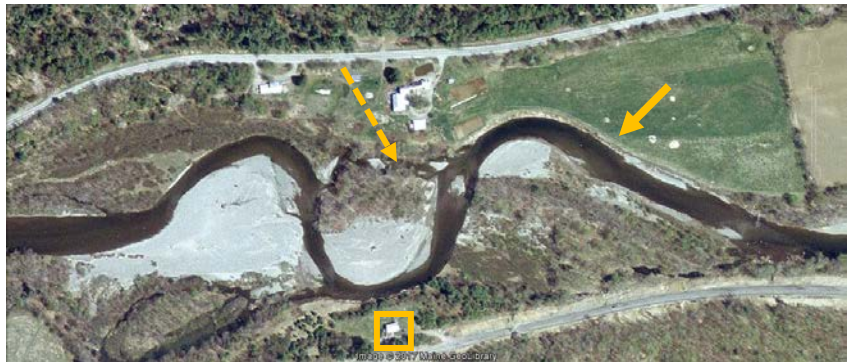
Figure 4a. Voter bar, Avon, ME in a rendering (top) from the Maine Geological Survey (Locke, 2001) and in 2003 (bottom, Google Earth, 2017). The house threatened by cutbank erosion in the late 1990’s – early 2000’s is indicated by the orange square. The dashed arrow points to the old channel that will be re-occupied and become the primary channel within three years. The solid arrow indicates the farm field that will experience significant erosion in the next decade, following the channel avulsion upstream (see Fig. 4).

The recent (twenty year) history of Voter Bar has been covered in a series of “Geologic Site of the Month” descriptions by Dan Locke (Locke 2001, 2006, and 2013). Beginning in 1998, property owners on either side of the channel have applied for a variety of permits to alleviate erosional pressure on cutbanks. As seen in Figure 4a, as the middle meander developed in the late 1990’s it began to threaten the home located on Rt. 4 (indicated by the orange box). At the time, state agencies suggested enlarging an old channel (dotted arrow) to capture flow from the main channel. However, before that work started, the river began to naturally re-occupy the old channel. In this image from 2003, the majority of the discharge is still in the main channel, but a significant volume has started to use the shorter path.

Even fifteen and twenty years ago, erosion along the downstream meander was resulting in loss of agricultural land on the Voter Vale Farm, indicated by the solid arrow. As the avulsion progressed rapidly upstream, this cutbank has retreated even more significantly as seen in Figure 4b. In 2012, the farm owners applied and were granted a permit to remove sand and gravel from both active point bars at this location. The rationale cited in the permit was that lowering the points bars would relieve erosional pressure on the opposing cutbanks by allowing the river to occupy a larger cross-sectional area during high water events (Locke, 2013).

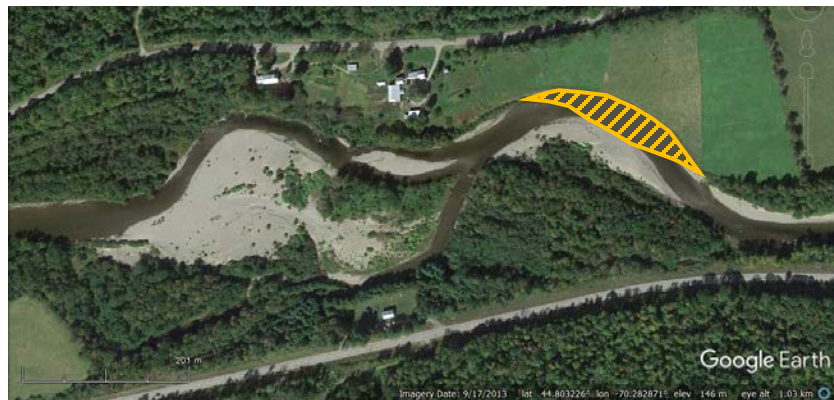
Figure 4b. Voter Bar in 2013 (Google Earth, 2017). The hatched orange area indicates field eroded in the previous decade as a result of meander migration.

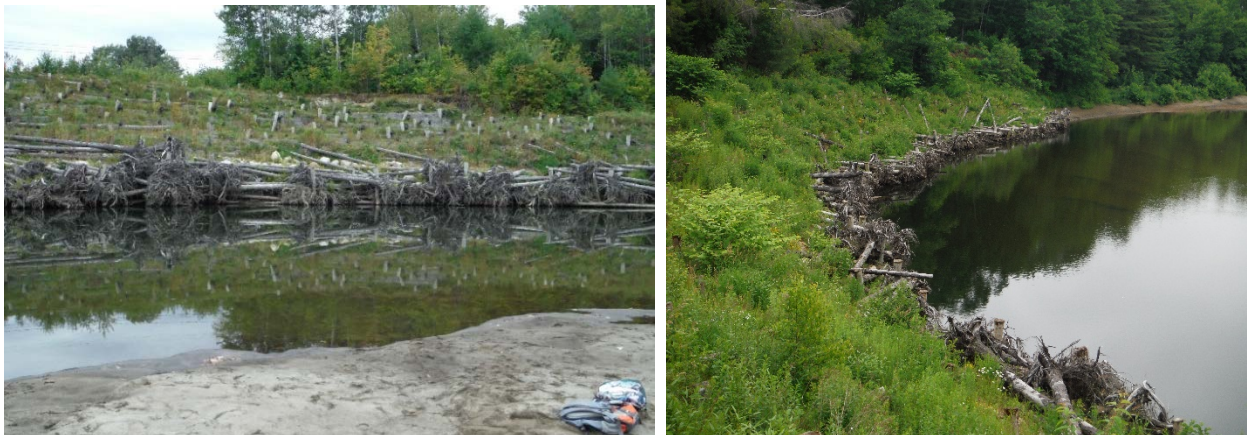
Figure 6. Two views of the rootball revetment at Stop 4 in Farmington Falls, 2014 (left) and 2017 (right). Initially, it was easier to see the shorter trunks, but as vegetation has established itself (right), only the rootwads at water level are easily visible.

“Soft” cutbank stabilization strategies include construction of a rootball (or rootwad) revetment. In this process, the slope is excavated and re-graded to be less steep, then tree trunks are buried in various orientations to slow water and improve slope stability. At the base, large trunks are anchored with their rootballs pointing upstream to help disperse energy during highwater events. These trunks are locked in place with buried boulders, and other tree trunks are partially buried in more vertical positions higher on the revetment. Vegetation is encourage to grow on the surface, further promoting stability.

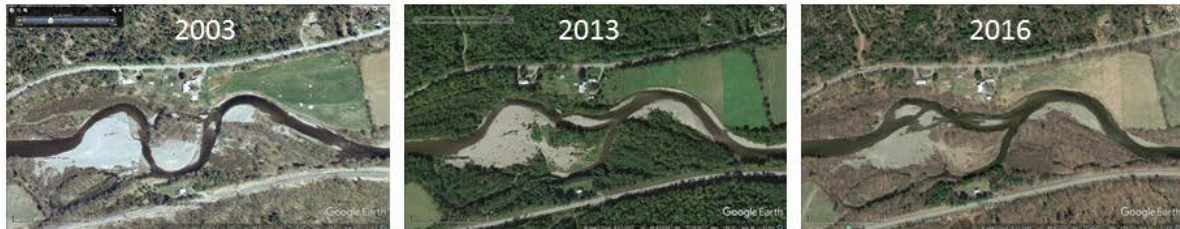
Figure 7. Time series of Voter Bar, highlighting migration of the main channel since 2003 (Google Earth, 2017). After the middle point bar was abandoned, the upstream and downstream bars continued to accumulate sediment and migrate slowly downstream. Sand and gravel removal in 2015 from the upstream bar altered flow in the main channel.

Continued land loss on the north side of the river, especially due to migration of the downstream bar into the agricultural field, prompted property owners to approach Maine DEP for permits to mitigate erosion in the early 2000's. Initially approved to install rootball revetment on the downstream cutbank to protect their field, the owners couldn't afford the quarter-million dollar cost of construction (Hanstein, 2012). In 2012, the owners submitted an application to remove sand and gravel from both the upstream and downstream bar; the state approved this project as a two-phase plan (phase I: upstream bar, phase II: downstream bar) (Locke, 2013).

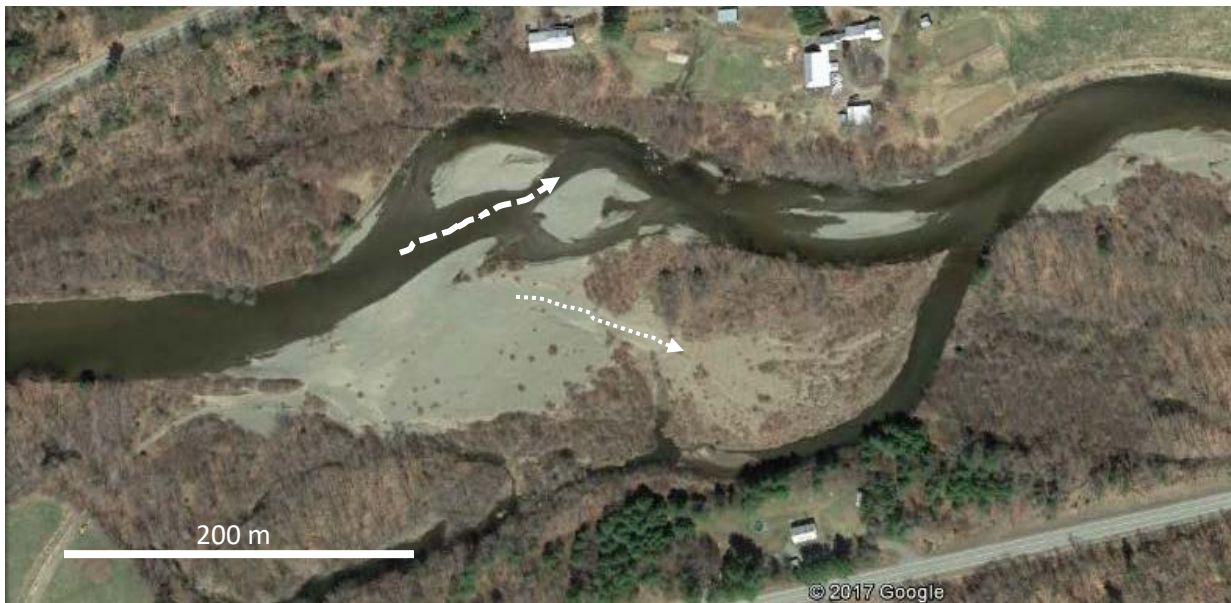
Figure 8. The most recent Google Earth image of Voter Bar, acquired in 2016 (Google Earth, 2017). The main channel now follows only the dashed arrow. Prior to sand and gravel removal, the main channel was adjacent to the cutbank on the north side. A prominent chute, used during highwater flows, is shown by the dotted arrow. This path would have been the presumed new channel had the river migrated naturally.

Following sand and gravel removal, the upstream part of the channel re-located to the excavated area, abandoning the upstream cut bank and effectively slowing erosion along that surface. It is likely that the old channel will still be occupied during high water events, leading to some continued erosion in that area. Since 2003, the

channel upstream of the third (downstream) bar has shortened significantly, potentially increasing the rate of erosion at this location.

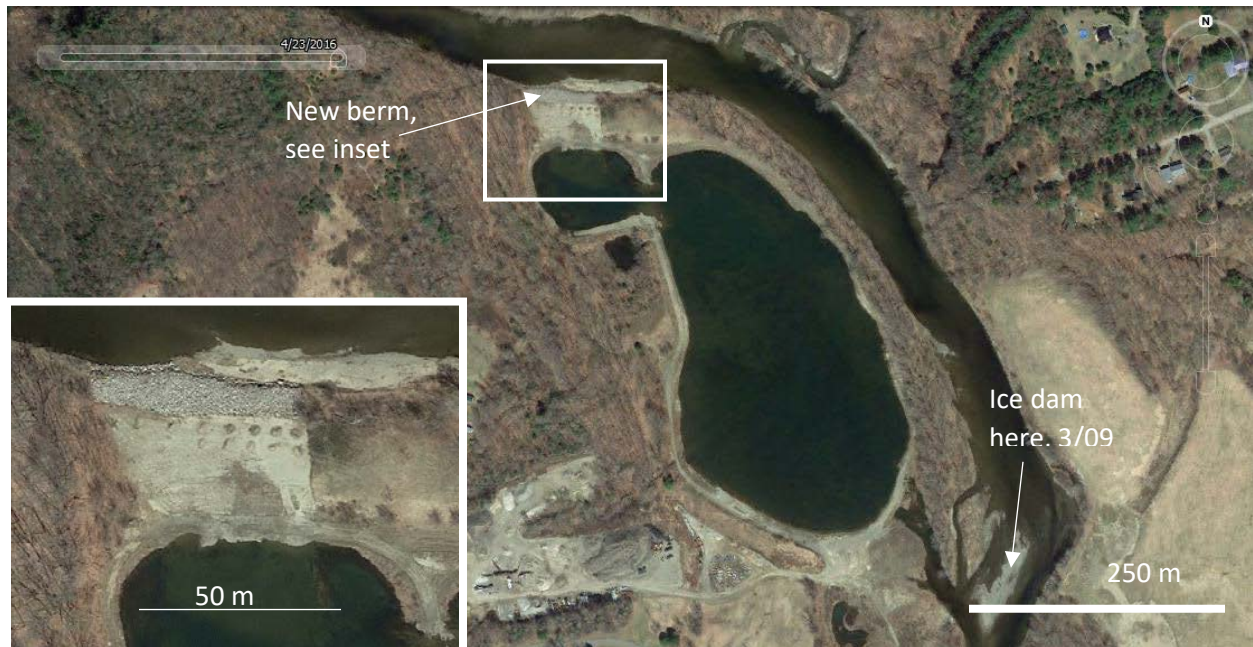
Figure 9. The most recent Google Earth image of Vining Bar, acquired in spring 2016. The new berm structure, closing the breach created during highwater in 2009, is indicated. A detail of this structure is shown in the bottom left (Google Earth, 2017). River flow at this location is from north to south.

A well-established flooded borrow pit was breached during a highwater event in March, 2009. A small ice dam formed on a downstream point bar, backing up water locally. The narrow berm left at the north end of the point bar was breached, causing sediment to wash into the ponds and diverting flow from the main channel (Figure 10). The property owners value the wildlife habitat provided by the ponds, and constructed a large

berm with a riprap surface to fill the gap eroded during the breach. Since construction, a modest amount of sand has accumulated in front of the berm, providing some buffer from erosion during high flows.

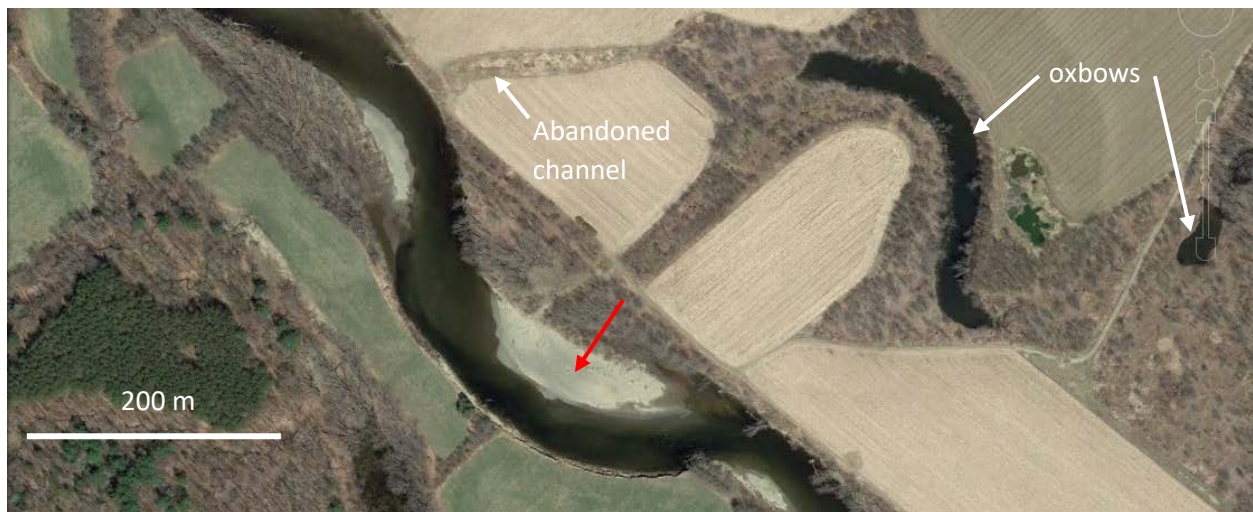
Figure 11a. The most recent Google Earth image of Lindbergh Bar (indicated by red arrow), acquired in spring 2016. This relatively small point bar is associated with a cutbank that is actively eroding agricultural land on the opposite bank. The property owner is planning to submit an application for sand and gravel removal. Flow is from northwest to southeast (upper left to lower right).

The Lindbergh bar (Figure 11a) is an example of a point bar that has not recently been altered for erosion control. In contrast to the larger grain size seen on the surface of some of the upstream locations, this bar is located along a shallower gradient of the river with slower velocities, resulting in finer sediments on the

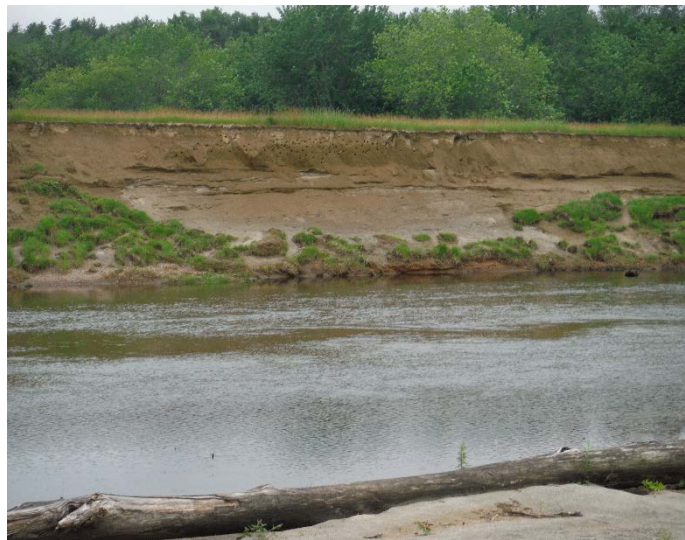
Figure 11b. View across the river at the Lindbergh bar. Note sand accumulated next to tree trunk in the foreground, and the thick section of floodplain sands and silts exposed in the cutbank. The river downstream of Farmington is incising the cohesive, clay-rich Presumpscot Fm.; this is exposed during low flows.

surface of the bar. The opposing cutbank (Figure 11b) shows a thick section of floodplain sands and muds overlying the clay-rich Presumpscot Formation that hosts the channel in the downstream reaches of the river.

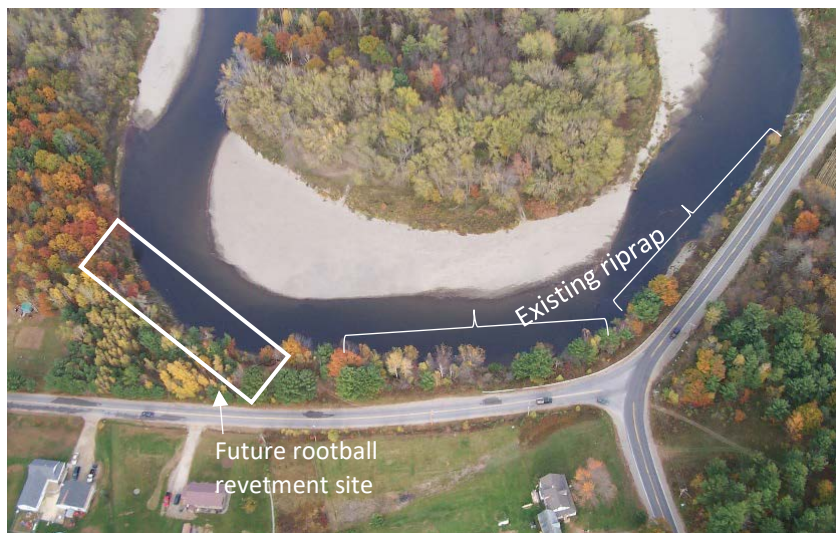
Figure 12. View of the Meader Bar in fall, 2011. Older riprap along Rt. 156 is indicated, and the extensive upstream point bar is in the center of the photo. River flow is from left to right. The future site of the rootball revetment constructed to protect Whittier Road is outlined.

As a result of rapid erosion during Hurricane Irene (August, 2011), the Sandy River threatened to undercut Whittier Road. A two-year permitting and construction process followed, resulting in the implementation of two mitigation strategies at this location (Hanstein, 2012, 2013, 2016). The first step was to remove sand from the opposite point bars for the first time in a decade (Figure 13). The town was permitted to remove 12,000 cubic yards of sand in 2012 (Hanstein, 2012b), leaving a low berm around the margin of point bar. Beginning in 2013, a large rootball revetment was constructed at a cost of over \$450,000 (Hanstein, 2013). The final steps in stabilizing this bank were completed in subsequent years as vegetation grew over the surface of the revetment. Two rounds of plantings failed, but a recent invasive, Japanese knotweed, colonized the bank and provided the necessary cover. The rootball revetment has successfully survived three years with the major logs in place.

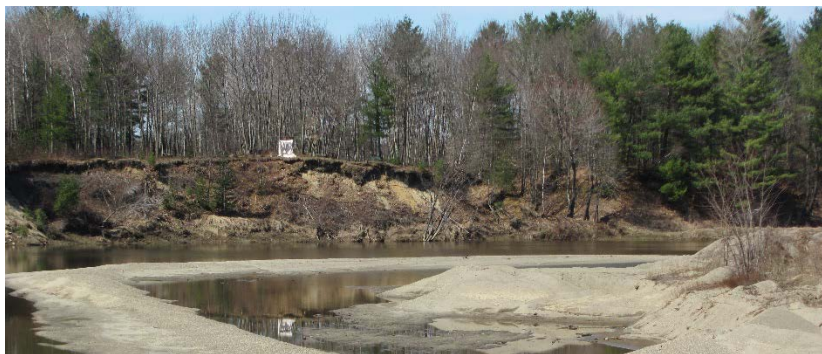
Figure 13. View across the upstream bar to the eroding cutbank in March, 2012. Sand and gravel were removed during the low water period in fall 2011; a berm was left around the margins of the bar. During spring high water, the lower center of the bar is flooded and sediment is re-distributed from the berm.
